Device	-	Bungee Trampoline
Client	-	Airmax Inflatables Ltd
Date	-	29.3.17
Manufacturer	-	Airmax Inflatables
Generic Name	-	Mobile 4 in 1 assisted bounce device
Serial number	-	NK
Year of Manufacture	-	2017
Inspection type	-	Design Review
TMA reference	-	GS.BT.DR
Comment	-	This Design Review is only applicable to the mobile 4 in 1 Bungee Trampoline produced by Airmax Inflatables

DESIGN REVIEW

1.0 **Brief** - TMA Ltd was commissioned by Airmax Inflatables Ltd to carry out a Design Review, Initial Test and Assessment of Conformity to Design, under the 'Amusement Device Inspection Procedure Scheme' (ADIPS) for their Bungee Trampoline, Manufactured by Airmax Inflatables. This design review is for a device that is one of a series.

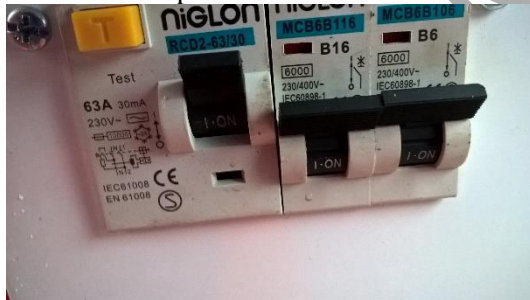
7. Failure of protective overload devices

A 16amp Circuit breaker is provided for short circuit protection.

We feel that separate CB's for each winch would be more suited to this installation
